## Reservoir Sheet Pile Cut Off Wall

### Island Barn Reservoir, London

Sheet Piling (UK) Ltd have recently completed an innovative and technically challenging project at Island Barn Reservoir in West Mosley, London.

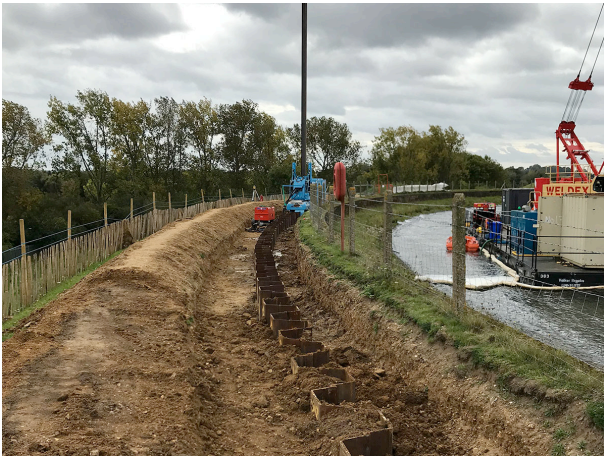
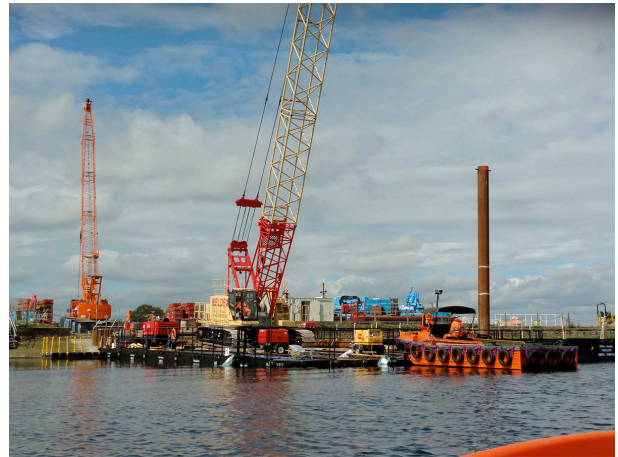
Once moved into position using the workboat the Giken Pile Press was lifting into location on a specially prepared platform over the centreline of the puddle clay core and installation of the 18.3m long Arcelor Mittal PU32 section sheet piles commenced.

The only plant located on the reservoir embankment was a Giken F201 Pile Press and Power Pack together with 2no piling operatives. All remaining equipment was located on the barge thus avoiding excess temporary works to the embankment which would have otherwise have been required.

By utilising the benefits of a 'Silent Vibrationless' hydraulic pile press which could be floated across the reservoir on the purposely built pontoon, Sheet Piling (UK) Ltd were able to demonstrate numerous additional advantages of the proposed solution.

The pontoon barge was then assembled using 25no Volker Brooks Unifloats, and an 80Te Weldex Crawler Crane was loaded onto the barge followed by ancillary
